# **INDOOR AIR QUALITY ASSESSMENT**

**Hiram L. Dorman Elementary School  
20 Lydia Street  
Springfield, Massachusetts**

Prepared by:  
Massachusetts Department of Public Health  
Bureau of Environmental Health Assessment  
August, 2002

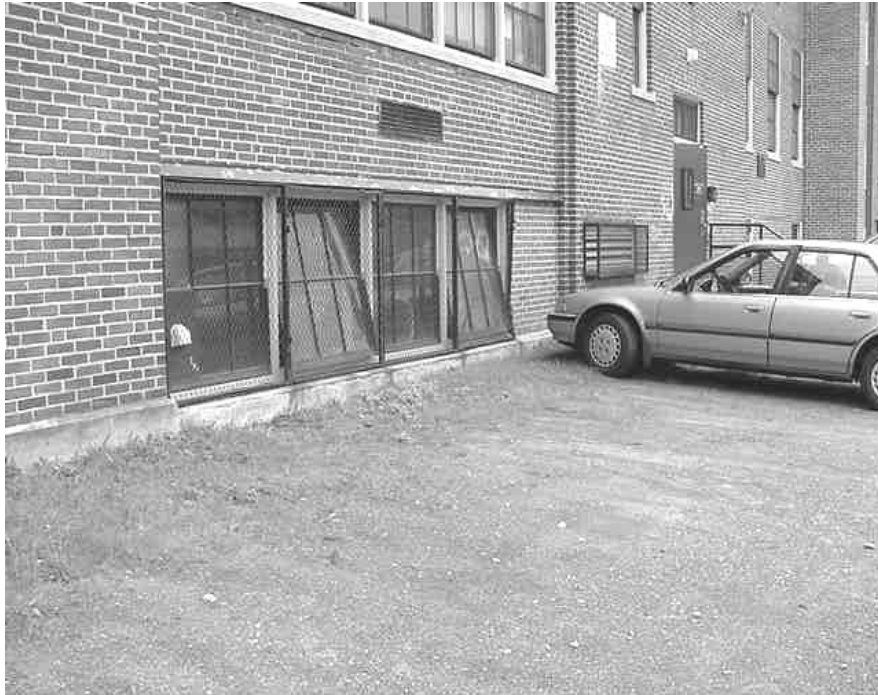
**Picture 1**

The school consists of two separate buildings. The original DES is a two-story red brick building with basement constructed in 1932. An annex, consisting of a two room, single story structure, was built in 1954. The DES annex is a freestanding structure and is the subject of a separate report. The DES contains general classrooms, main office, media center, kitchen and cafeteria/auditorium. The basement was originally constructed as an open area that was subdivided into offices, the former media center and teacher's lunchroom. Windows in both buildings are openable (see Picture 1).

**Openable Windows of DES on Basement Level**
